# **Inventory of Current Conditions and Land Uses**

## **Red Rock Road, Douglas County**

**Oregon Department of Environmental Quality  
and  
The Weyerhaeuser Company**

**June 2008**

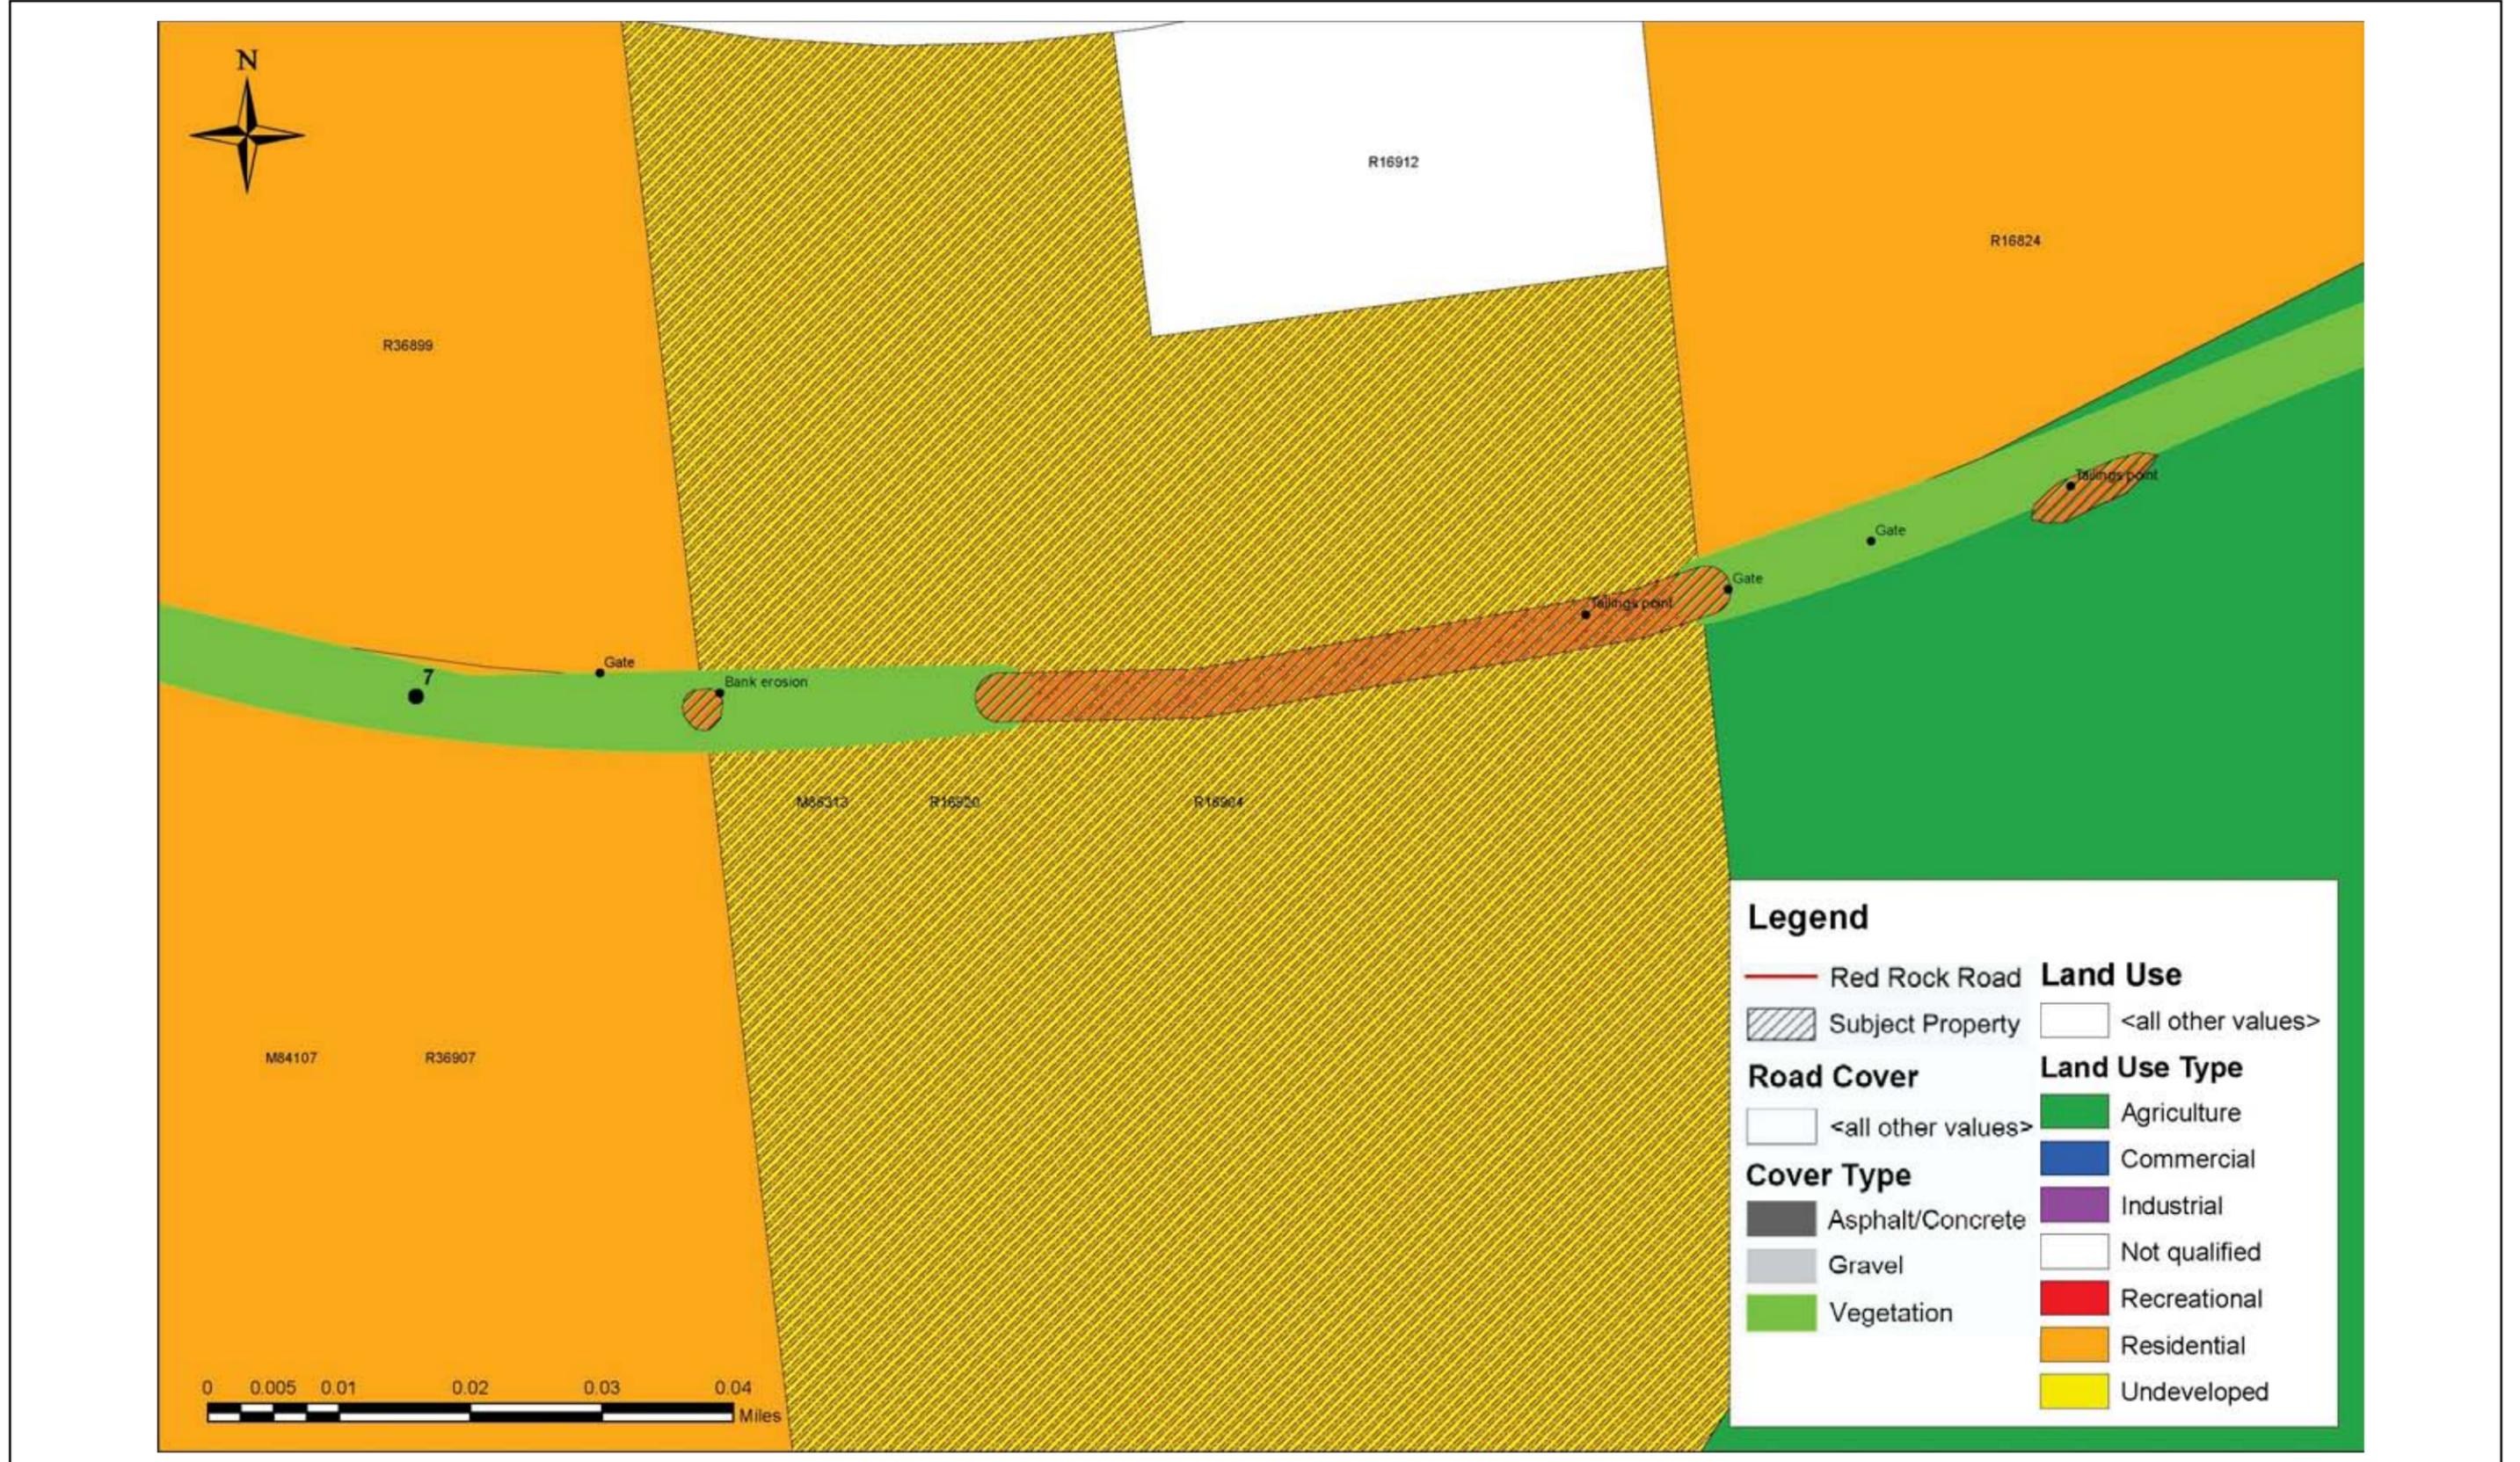
**Figure 10**  
**Map of Property #7**  
**Parcel R16904 and M86313**

This property (Parcel R16904) is about 300 feet south of Nonpareil Road on Bonanza Mine Road (Figure 10). The property has a house, a large garage, and a barn. Access to RRR is gated on this property, with a fence on the eastern side connecting to Bonanza Mine Road.

Tailings are exposed along the full length of RRR across this property, with only limited vegetation cover. A creek runs directly adjacent to (or within) the western boundary of the property and across exposed tailings along RRR. Erosion from high-flow events has caused major changes to the RRR crossing. Exposed tailings from RRR are visible and are currently being eroded by the creek on the western edge of the property.

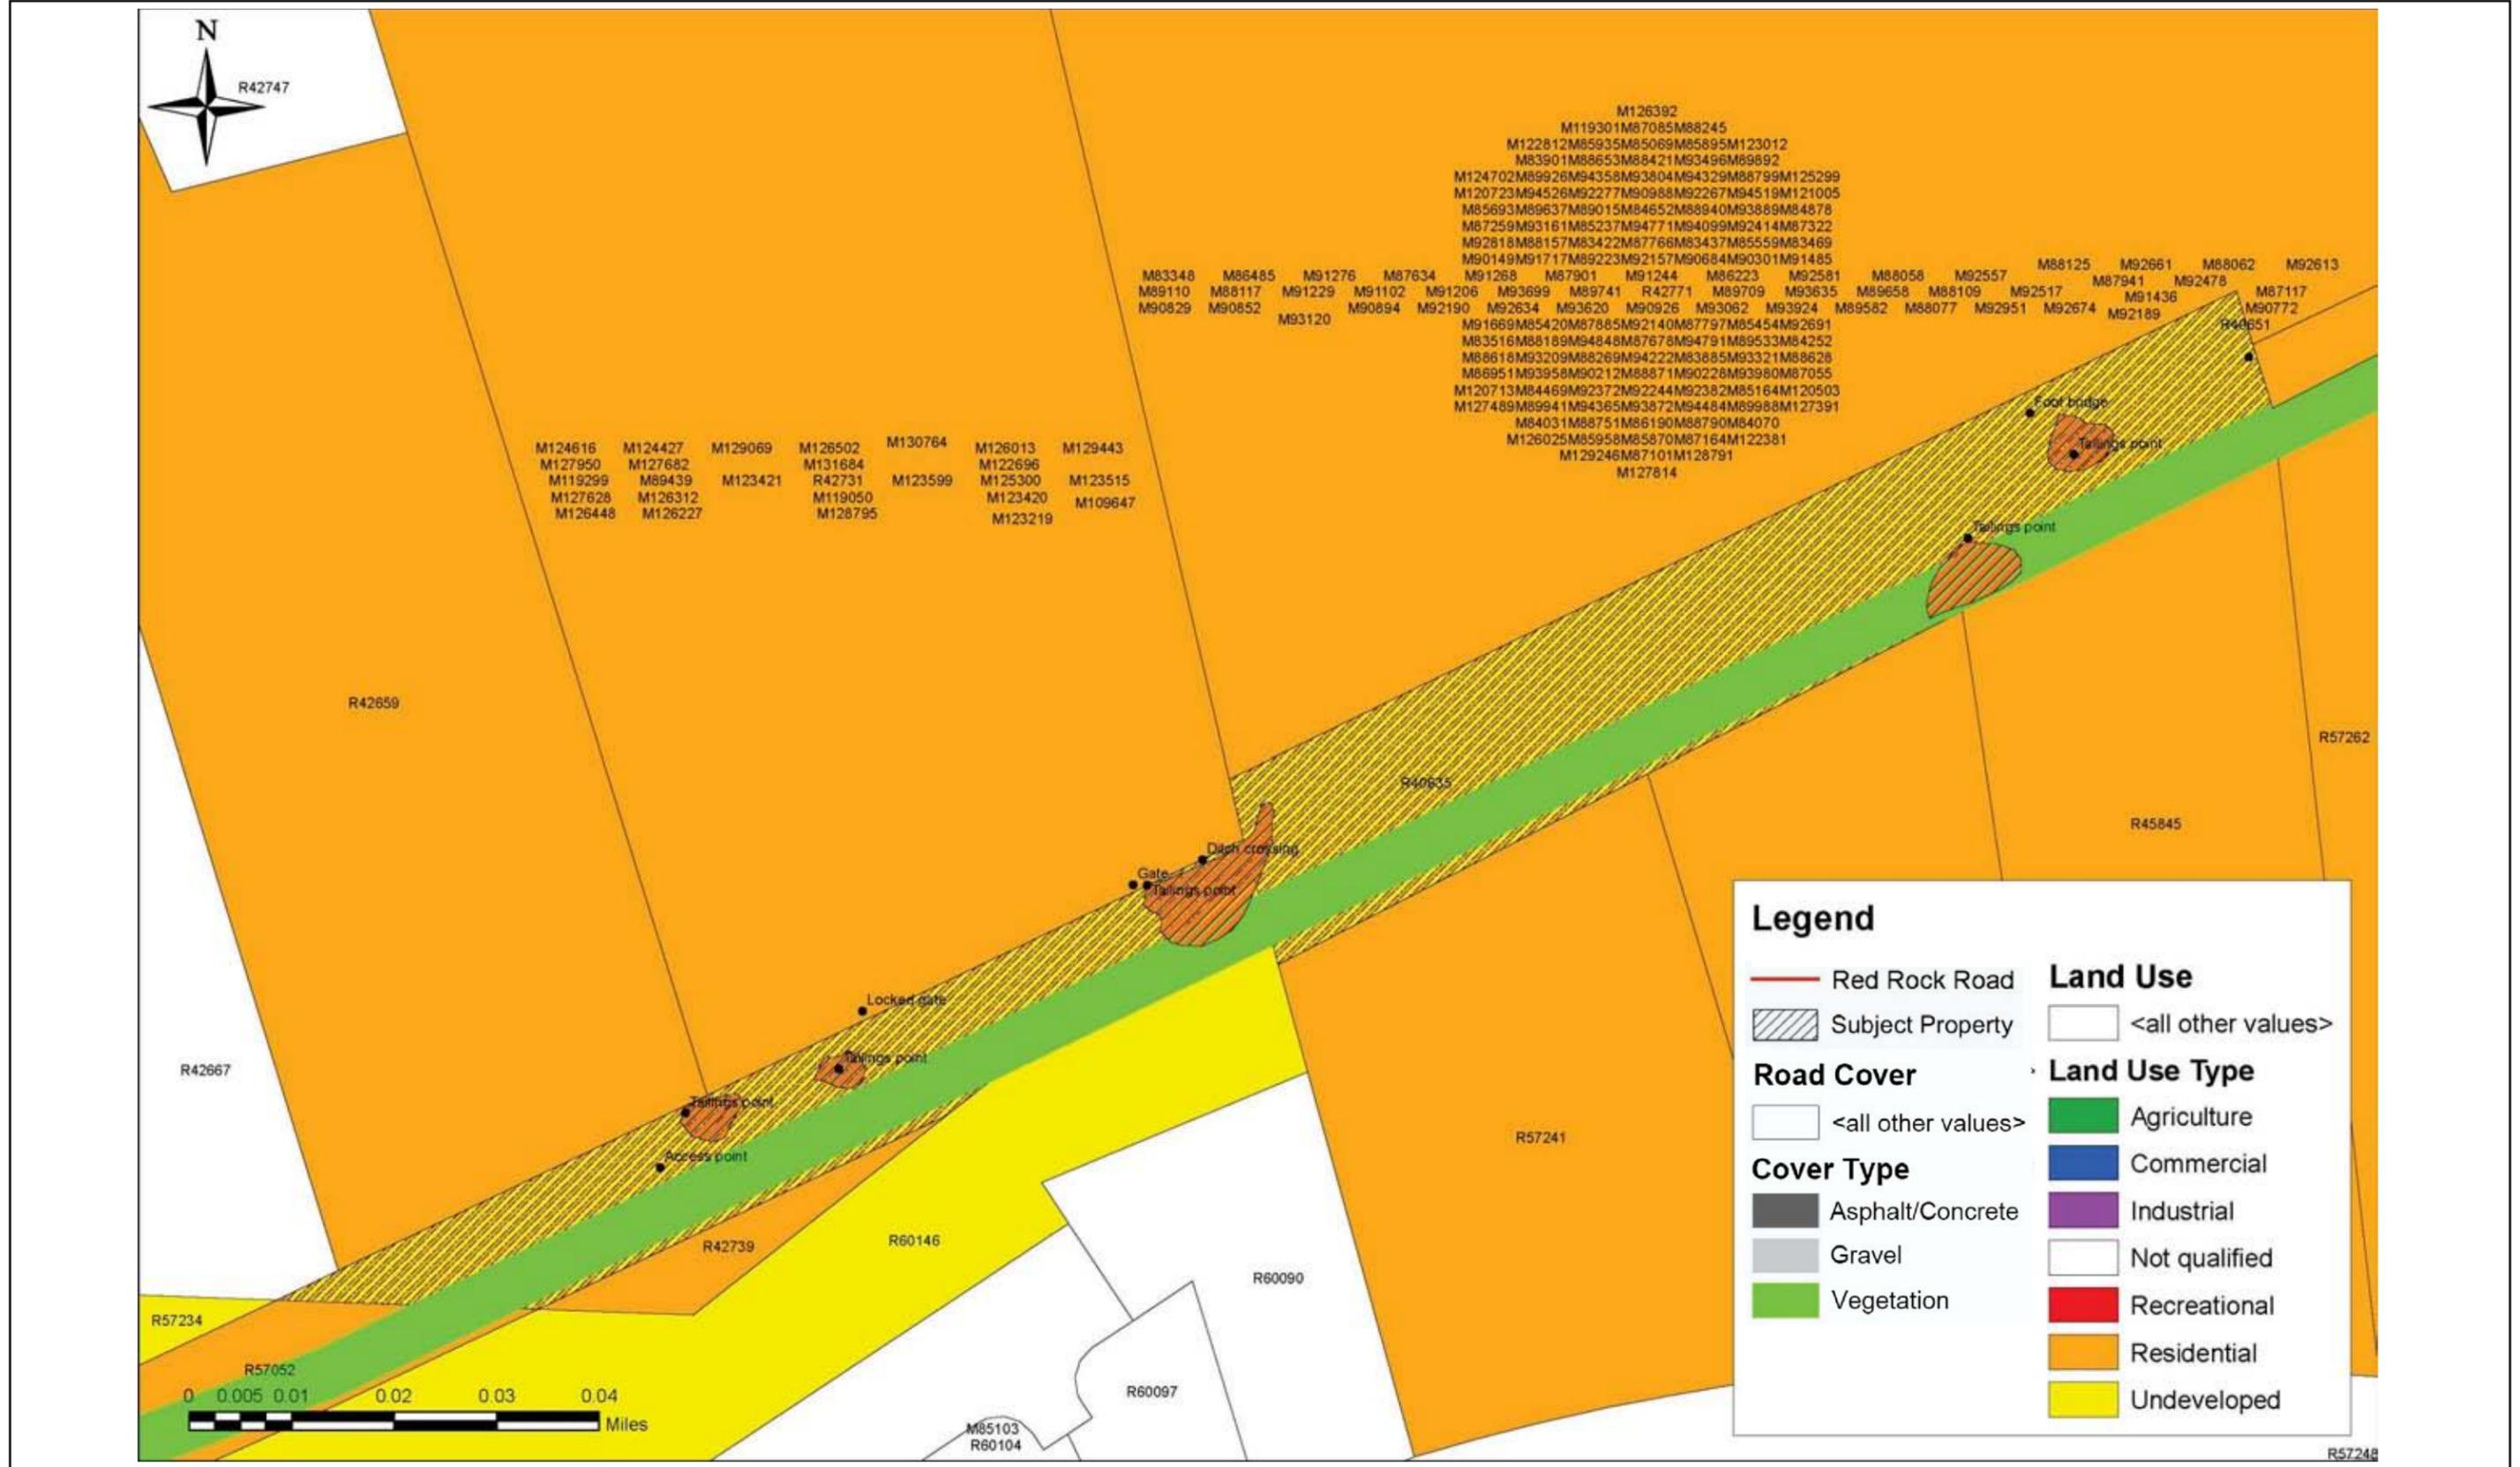
**Figure 11**  
**Map of Property #8**  
**Parcel R40635**

This property (Parcel R40635) is directly behind a mobile home park (Figure 11) about one-half mile east of Sutherlin. It is primarily used by local residents for walking and recreation. A creek runs adjacent to the parcel on the southern side and multiple mobile home units are on the northern side.

Several large areas of tailings are exposed on RRR in this property. Some of these exposed areas are used for footpaths and bird feeding areas. On the creek side of the property, erosion appears to be causing tailings to be exposed. Little or no fencing occurs between the mobile home park and the right-of-way, leading to a high level of access to the exposed areas.

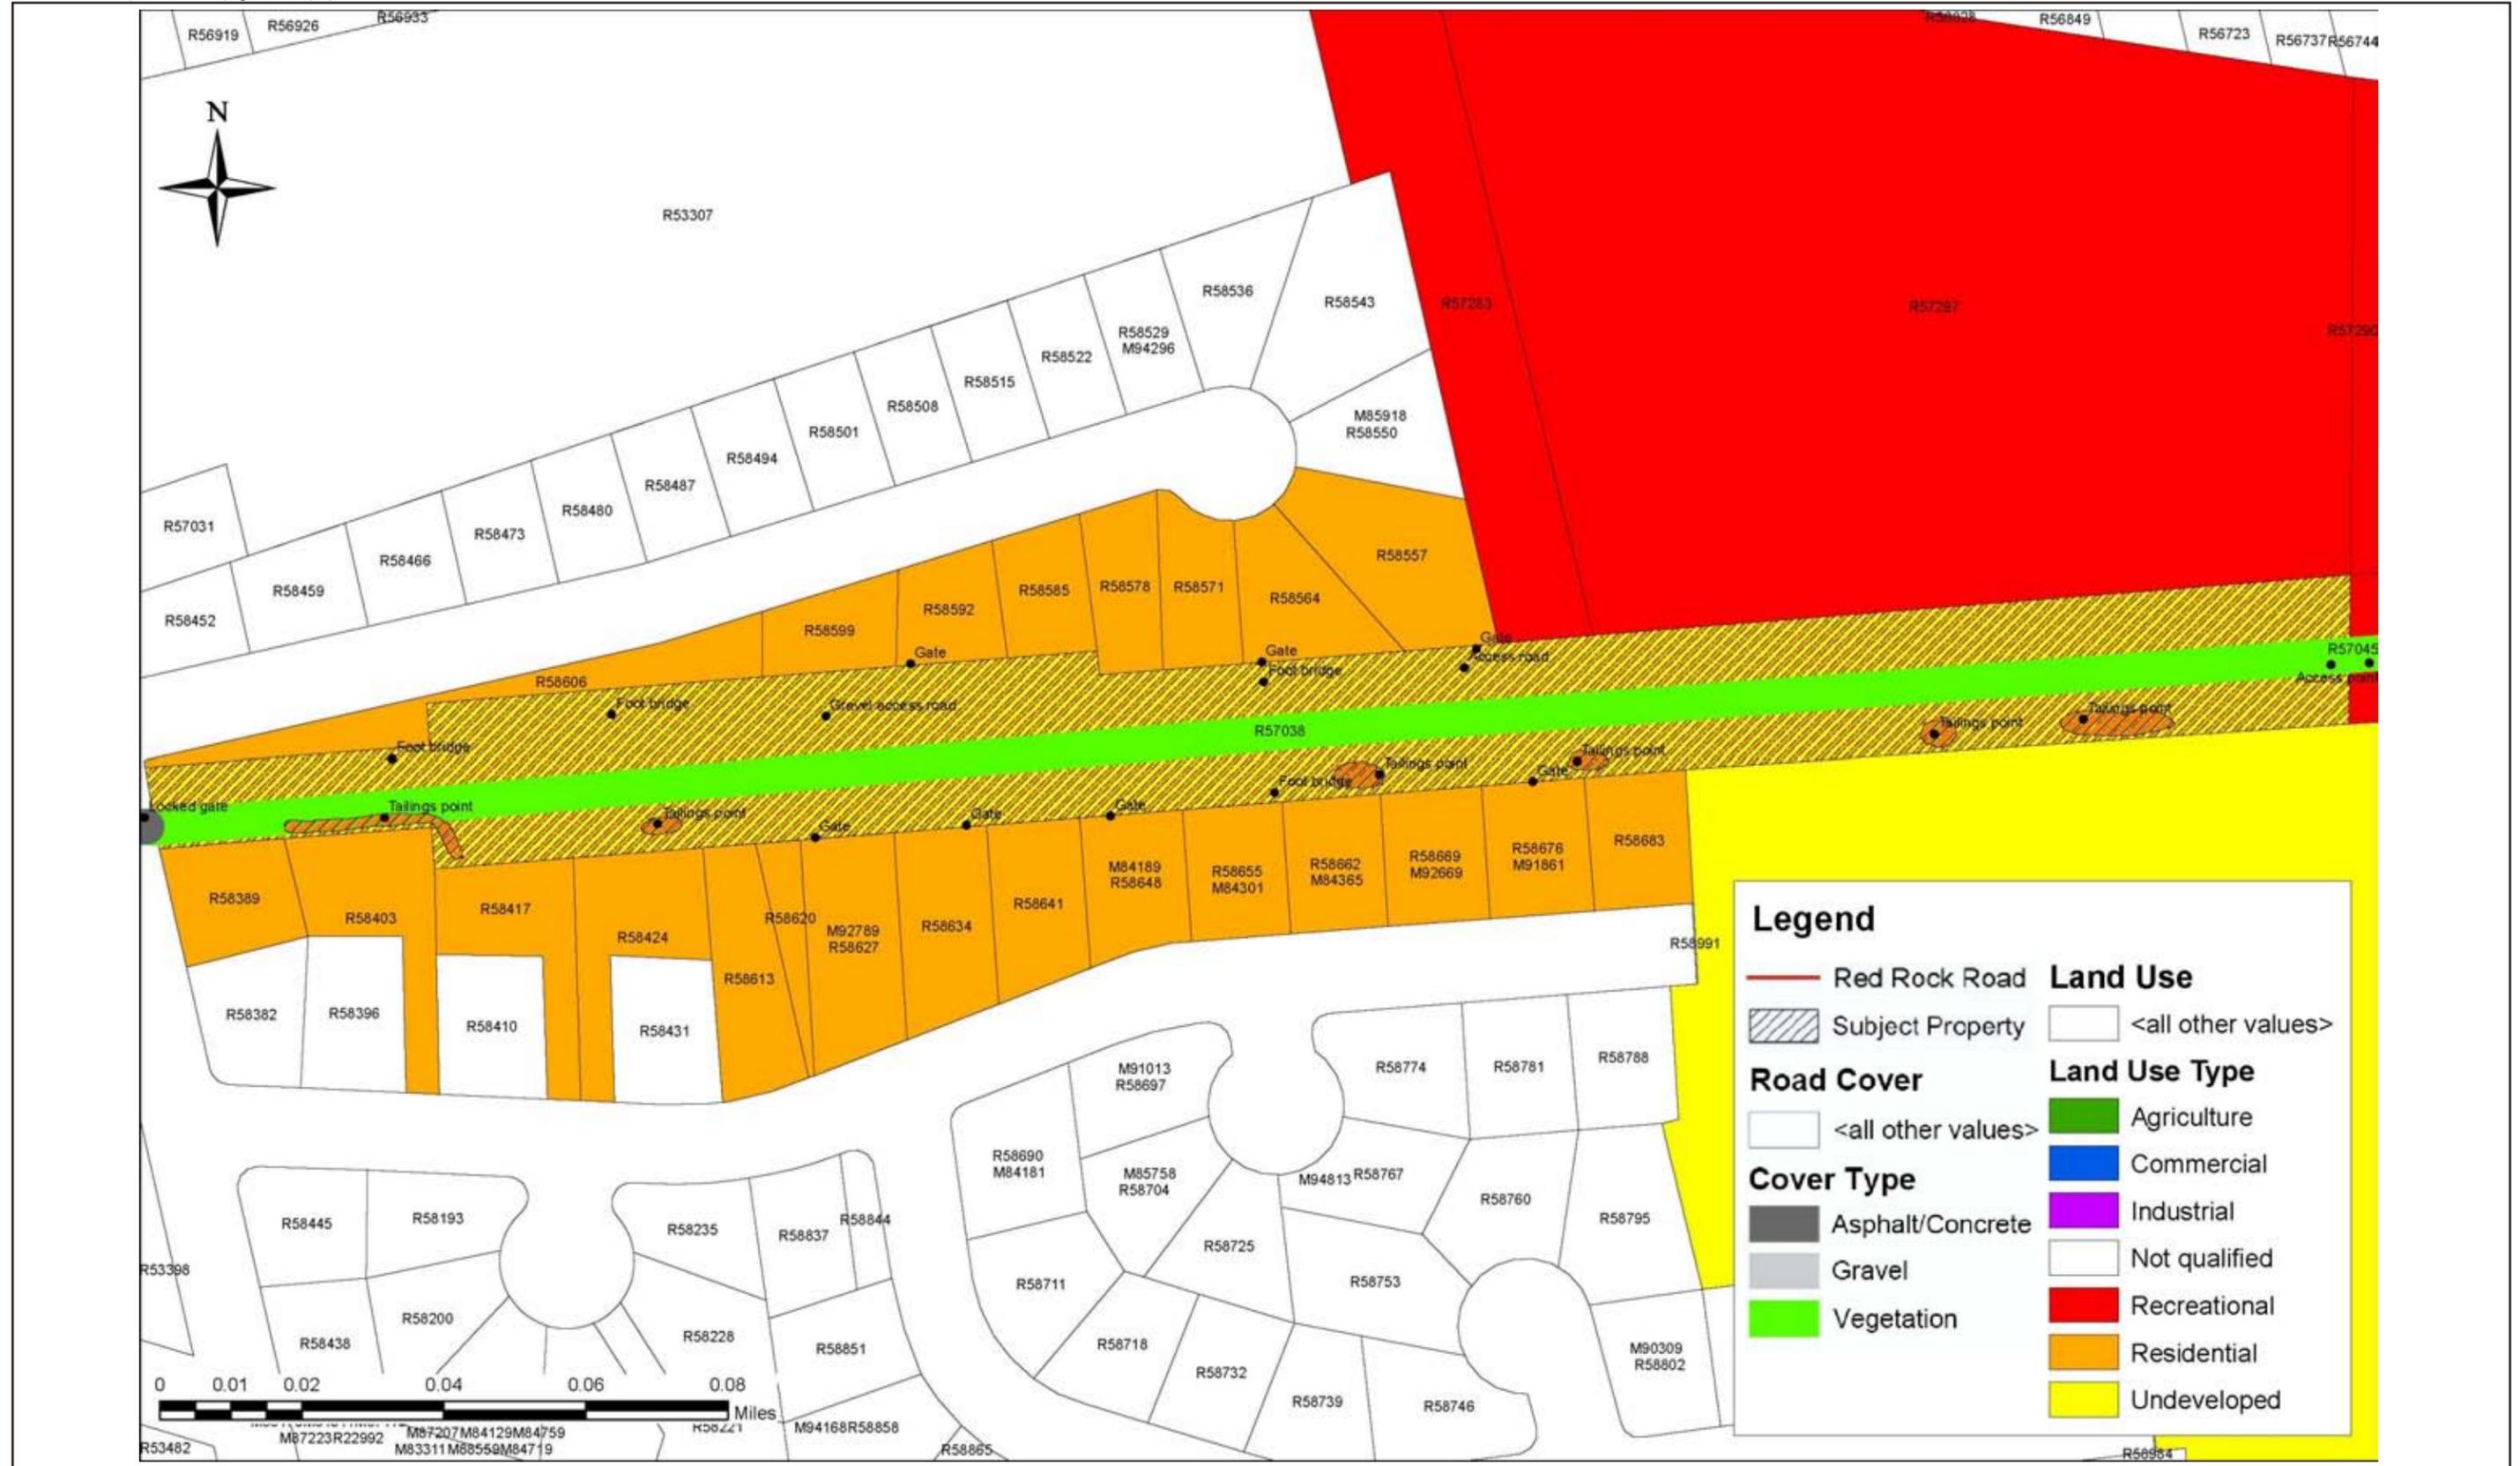
**Figure 12**  
**Map of Property #9**  
**Parcel R57038**

This property (Parcel R57038) is near South State Street (Figure 12) in Sutherlin. The property is being used as a right-of-way, with a fenced and gated entrance on the western side and a cinder block barrier on the eastern side that blocks vehicular access. There are no structures on the parcel.

Tailings are exposed at several locations along RRR on this property. Other areas of RRR are covered by gravel and low vegetation. Several parcels adjacent to RRR have access to RRR by gates large enough for vehicles, and several footbridges cross a ditch that lies parallel to RRR. The majority of the adjacent parcels are single-family residences.

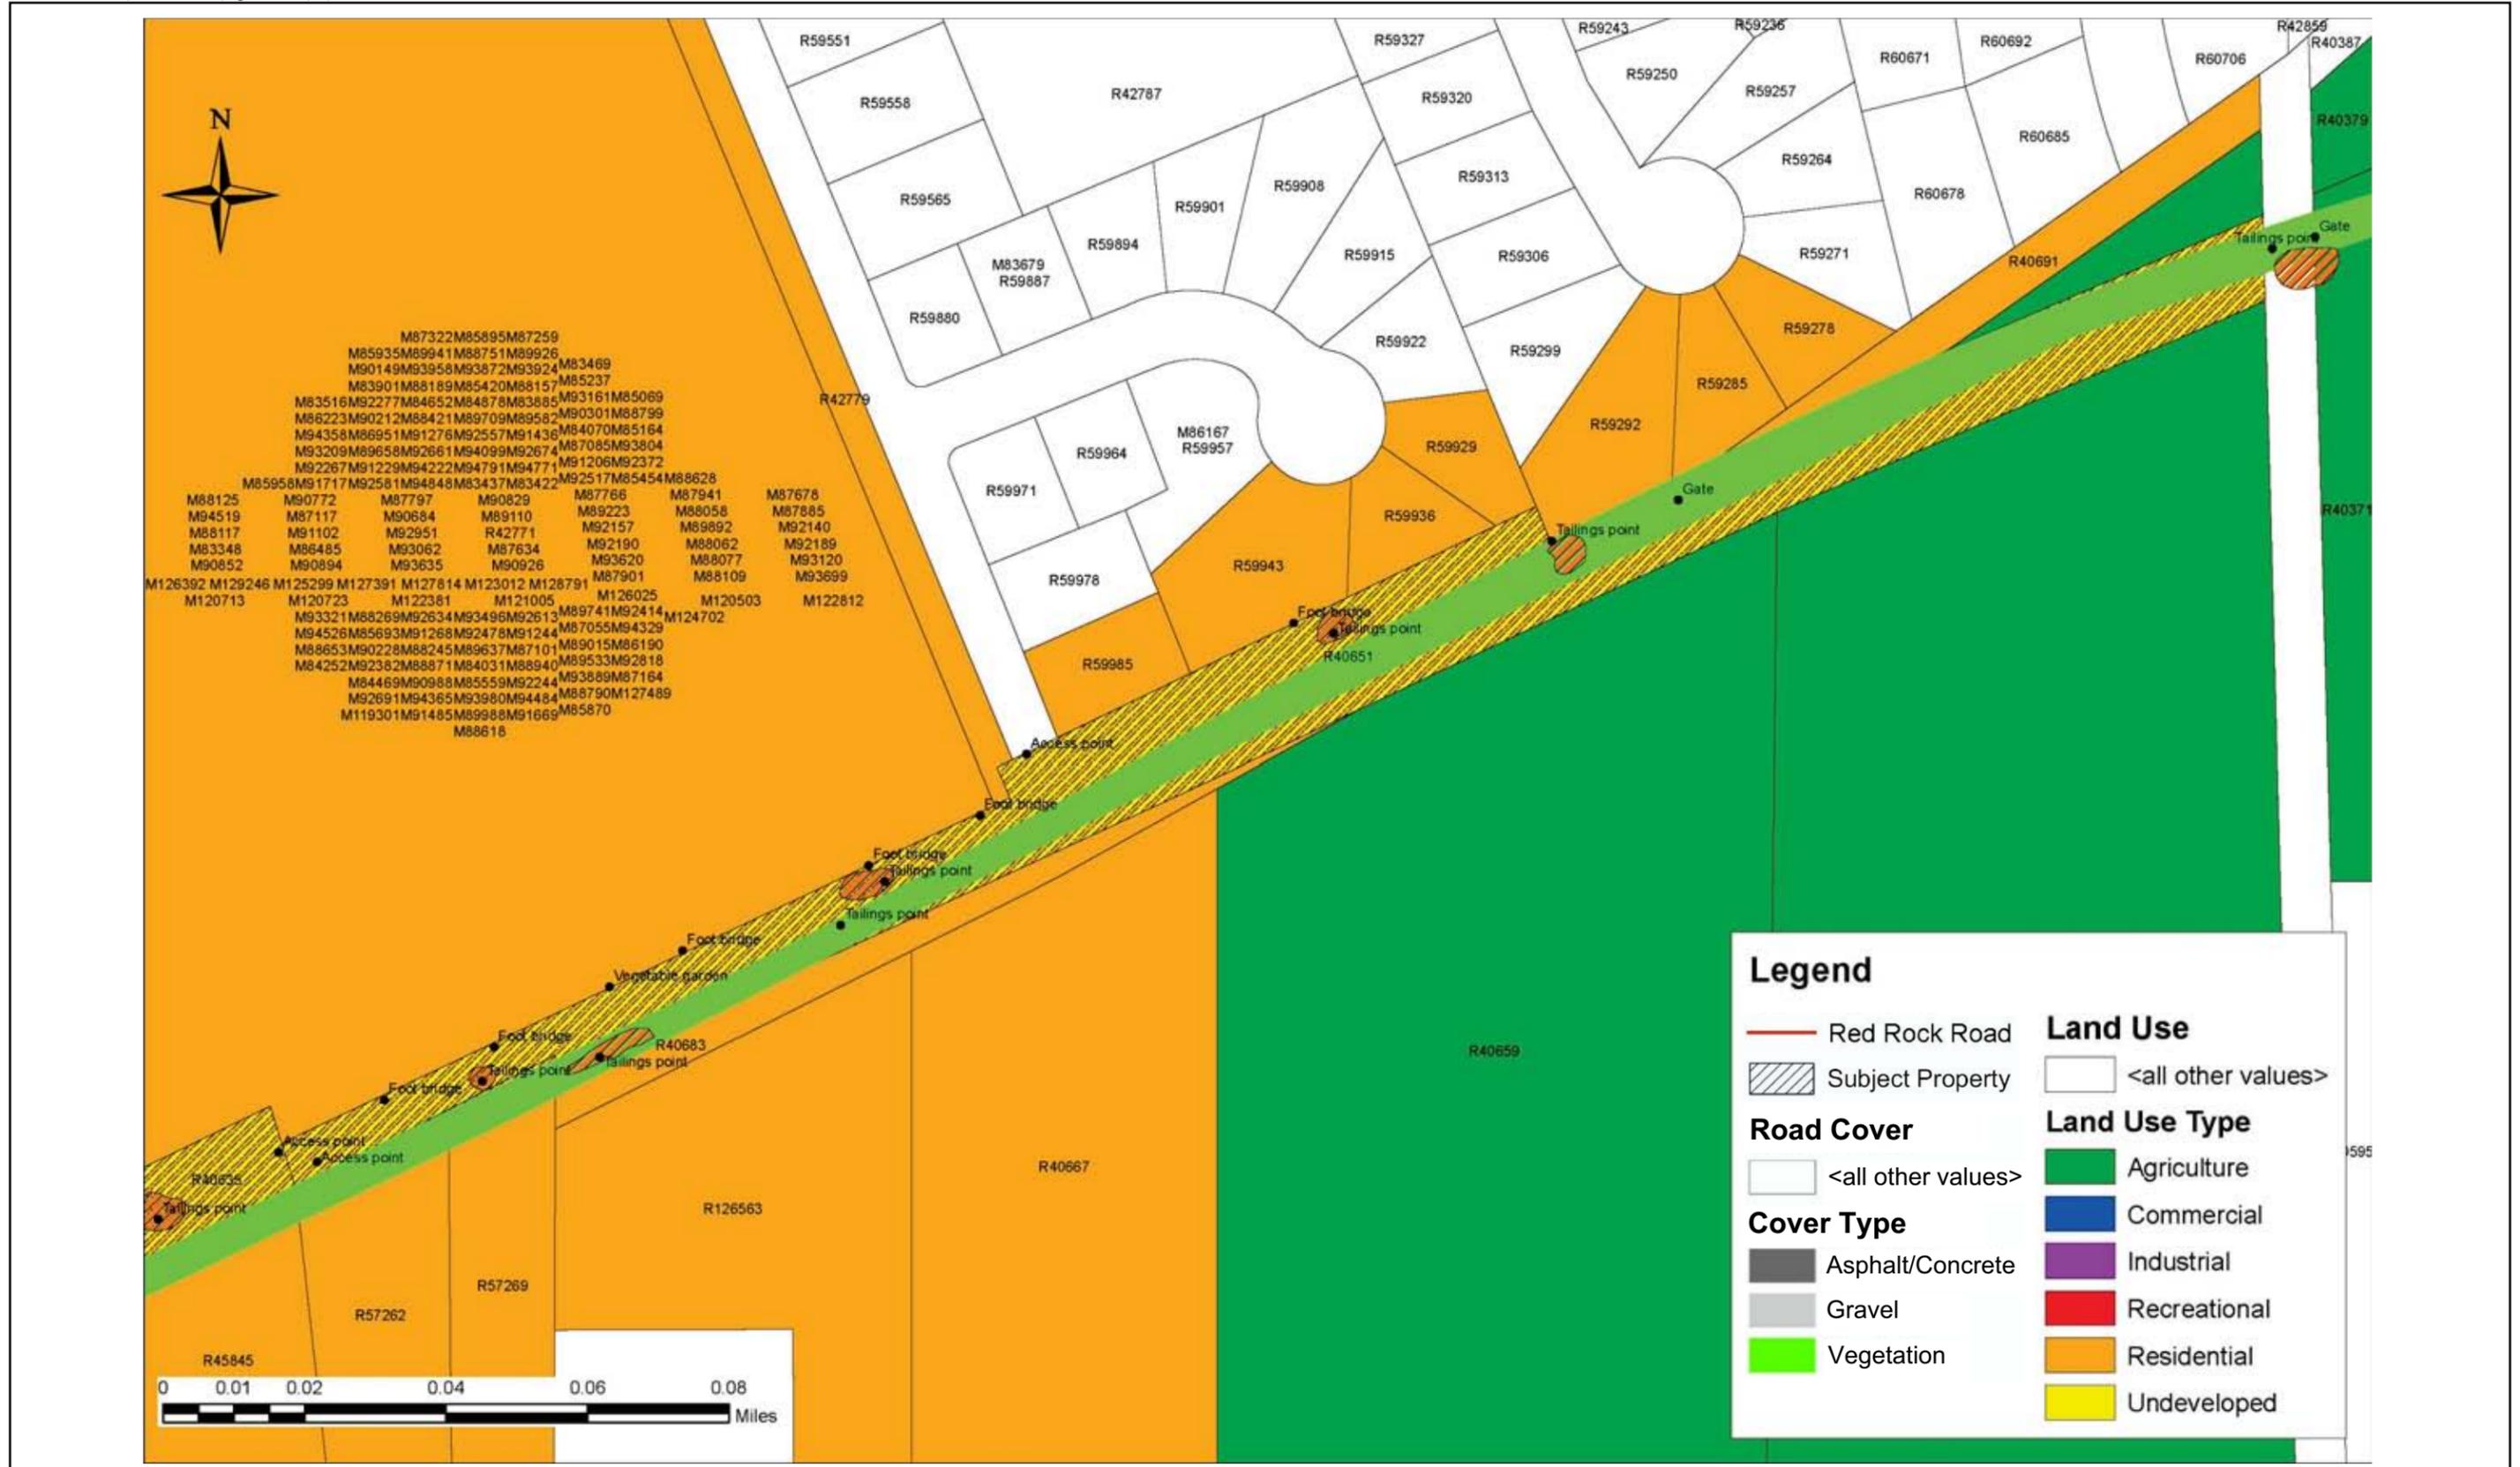
Figure 13  
Map of Property #10  
Parcel R40651

This property (Parcel R40651) is near the southern end of Sunny Lane (Figure 13). The property is bordered on the south by Sutherlin Creek and a mobile home complex, and by a residential area on the north. There are no structures on the property and it has limited fencing. Access to this property appears limited to pedestrians, although one land owner appears to use it for a parking area or turn-around area.

Tailings from RRR are exposed on this property in four areas: 1) a footpath, 2) two areas where Sutherlin Creek is eroding a bank cut into RRR, 3) an area where a feeding trough and bird feeders for local wildlife have been installed behind a mobile home, and 4) an area across a drainage ditch on the eastern side of the property. These areas are accessed by local residents. Most residential parcels to the north have direct access to this property and have footbridges and/or gates providing access to RRR. A few of the mobile home park residents have planted vegetables or decorative plants on the surface, or banks, of RRR.

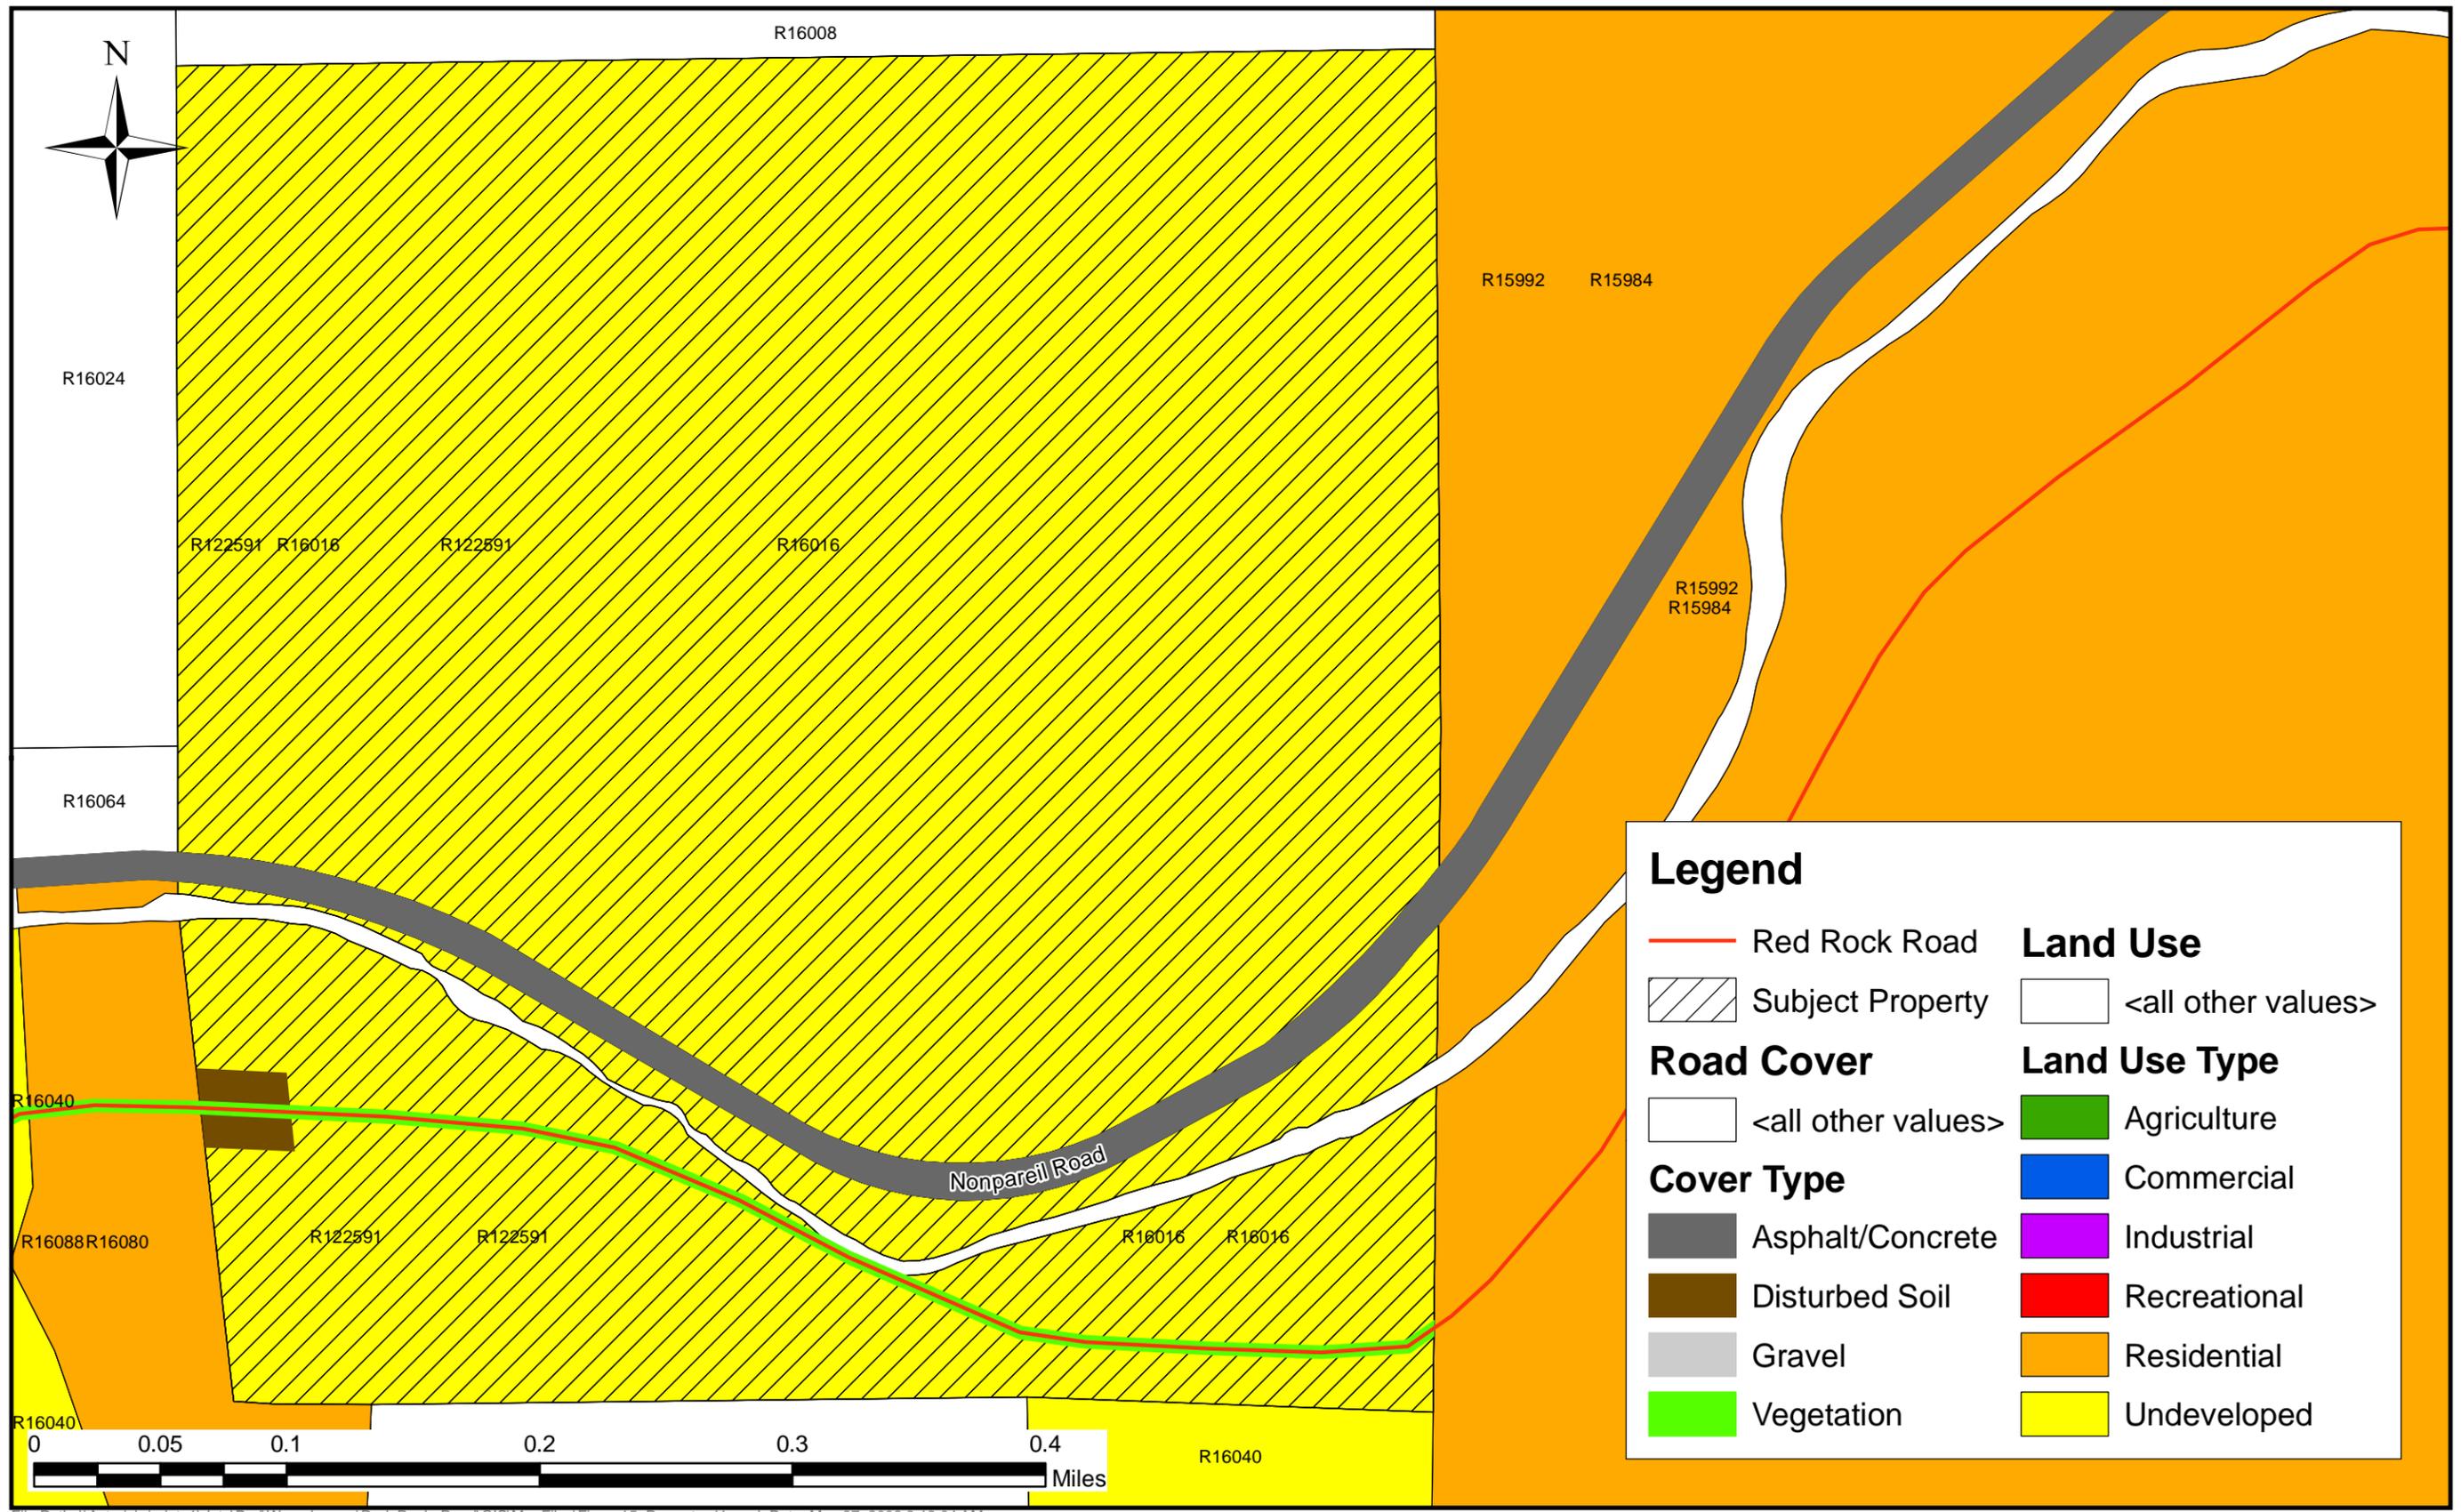
Figure 15  
 Map of Property #11  
 Parcel R122591 and R16016

property; however, visual inspection from adjacent properties and aerial photos show RRR with a thin gravel cover with visible red soils showing signs of vehicle or tractor activity. No buildings or structures were observed in the immediate vicinity of RRR.
